6th International Building Physics Conference, IBPC 2015

Analysis of direct and flanking sound transmission between rooms with curtain wall facades

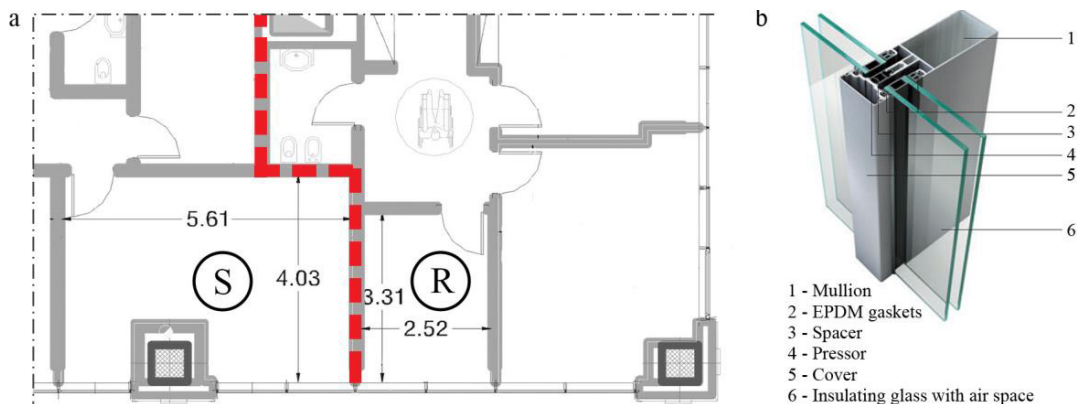
Fig. 1. (a) Plan portion of the building under test where: S = source room, R = receiving room, dashed line is the limit of two distinct properties; (b) detail of the curtain wall structure.

To better characterize the sound transmission through a curtain wall, the Apparent Sound Reduction Index of the partition between the adjoining rooms shown in Fig. 1.a was measured according to the procedure described by EN ISO 16283-1 [6], while velocity vibration measurements were carried out according to EN ISO 10848 [7].

The improvement intervention were realized in the junction between the separating wall and the curtain wall, where the wall thickness was reduced by the architects to allow the opening of the windows of the facade. Moreover, the curtain wall mullion was realized with a single aluminum section (Fig. 1.b).

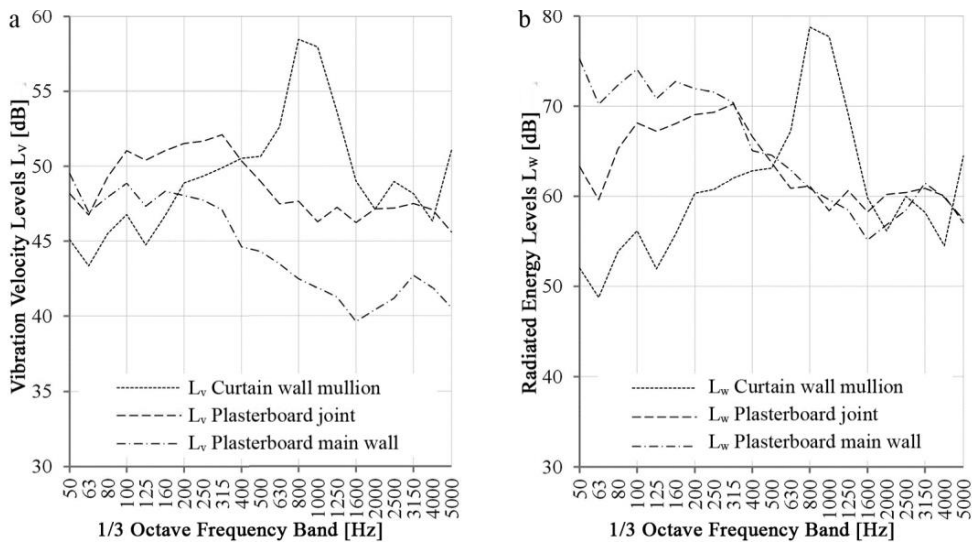
Fig. 2. (a) Measured velocity levels L_v in dB; (b) Estimated radiated energy levels L_w in dB.

Fig. 2.a shows the velocity vibration levels (dB ref. 10^{-6} m/s) of the three structures. Values are shown both as velocity levels (L_v in dB) in Fig. 2.a and as radiated power level (L_w in dB) in Fig. 2.b ($L_w=10\log_{10}(W/W_0)$, with $W_0=10^{-12}$ W), normalized to respective surfaces; in this comparison we have considered radiation efficiency $\sigma = 1$ at each 1/3 octave band and for all materials. Radiated power is calculated as follows:

Fig. 2 shows two main paths of sound transmission: transmission through the aluminum mullion of the curtain wall, and transmission through the reduced thickness plasterboard joint (three plasterboard layers directly connected to each other, see Fig. 4.a). It is clear that the sound insulation gap at 1000 Hz is due to the mullion of the curtain wall, although it has the smaller surface, compared to other components.

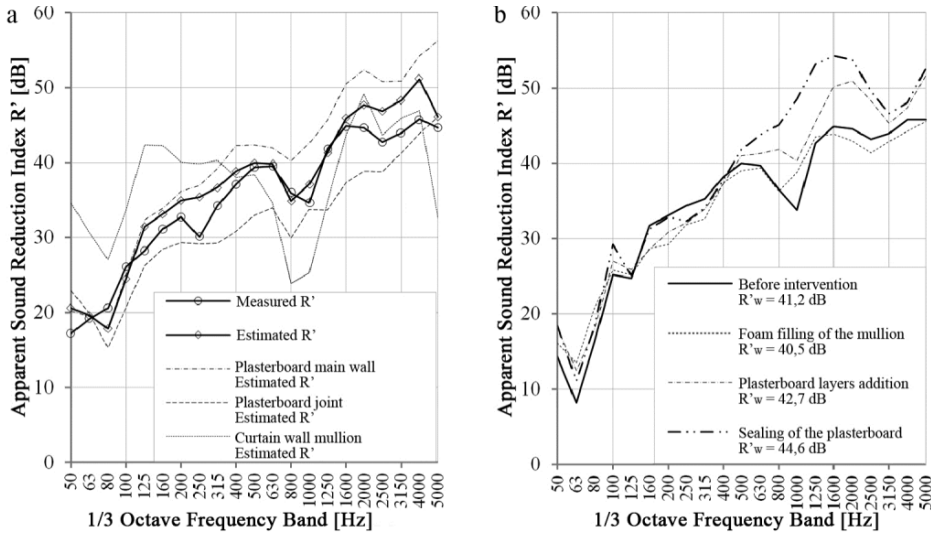
Fig. 3. (a) Graph of the Apparent Sound Reduction Index, R' , measured (EN ISO 16283-1:2014) and estimated with EN 12354-1, Appendix B.1 method. R' estimations for each element composing the wall are reported as well. (b) Graph of the Apparent Sound Reduction Index R' before (continuous curve) and after the interventions.

R' curve (Fig. 3.b) shows an irregular behavior around 1000 Hz: this kind of performance drop is usual to be expected around 2500-3150 Hz, which is the average coincidence frequency for plasterboard wall [9].

Using the approximations above explained, R' was calculated from the measured vibration velocity and compared to R' measured with EN ISO 16283-1 method. Only velocities measured over the main wall components were considered, due to the fact that flanking components have an average of 5÷10 dB lower L_v . Despite the approximations in the calculation of the radiation efficiency, a good agreement between the two R' curves is shown in Fig. 3.a. The continuous curve is R' estimated using the EN 12354-1 hypothesis; empty dots are the ISO 16283-1 measurement's values.

Errors between prevision and measurement are mainly included in a ± 3 dB range. Greater errors are presents at 250 Hz, probably due to the overestimation of the critical frequency f_c for the plasterboard joint. The used model

In spite of this, the apparent sound reduction index only increases at mid and high frequencies, as the graph in Fig. 3.b shows. This fact is due to different problems of the separating wall but mainly to the structural sound transmission through the metal mullion of the curtain wall. Moreover an increasing in the coupling between receiver and source side of the vertical aluminum mullion could be caused by the polyurethane foam filling: despite a lower dip at 800 and 1000 Hz, a wider frequency range, between 160 and 400 Hz, is affected by a significant worsening of the performance. This problem is only partially solved when a new plasterboard layer was added and sealed (dash-dot-dot line in Fig. 3.b).

Fig. 3.b shows that the lining of the vertical mullion of the curtain wall at the junction with the separating wall causes an average 3 ± 15 dB increasing of the apparent sound reduction index R' , at mid and high frequencies. The difference is instead not significant at lower frequencies where the resonance of the lining system described in Fig. 3.b reduces the acoustic performance of the partition. In particular it is interesting to note that the lining of the frame eliminates the insulation drop at 1000 Hz, which is probably due to a resonance of the mullion of the curtain wall. A similar problem was shown also in a previous study on this kind of junction [2].

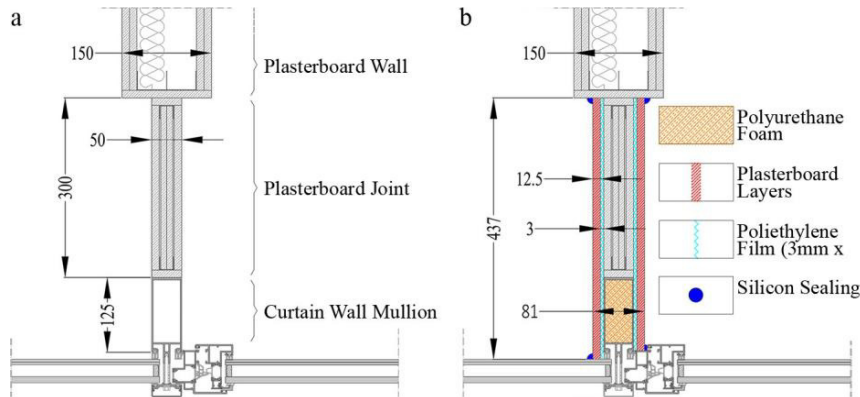
Fig. 4. The junction between the separating wall and the curtain wall before (a) and after (b) the improvement intervention. Dimensions are in mm. The main wall has a 5 cm mineral wool layer and an air gap of 5 cm.

Velocity level measurements were carried out using 2 grams mono axial accelerometers, randomly placed over the surfaces. Plasterboard main wall, plasterboard joint and metal curtain wall mullion, illustrated in Fig. 4.a, were first analyzed. Other flanking noise paths (floor, glazing, ceiling) were investigated too, but they had much lower velocity levels, compared to those measured over the main wall. In consideration of this fact, velocity levels for flanking components are omitted for brevity.

The intervention was limited by the need not to increase the wall thickness more than 2 cm per side, to allow the opening of the windows. Two layers of closed-cell polyethylene film 3 mm thick and a layer of plasterboard on each side of the separating wall were applied (Fig. 4.b). Furthermore, the vertical mullion of the curtain wall was filled with polyurethane foam.
