### **Religious buildings in Ortahisar (turkey).the Survey of the complex of Saklı and Ali Torun kilise. Hypogea 2015 - Proceedings of**

*The survey of Saklı Kilise and Ali Torun Kilise complex District Eski / Atik Mahalle*

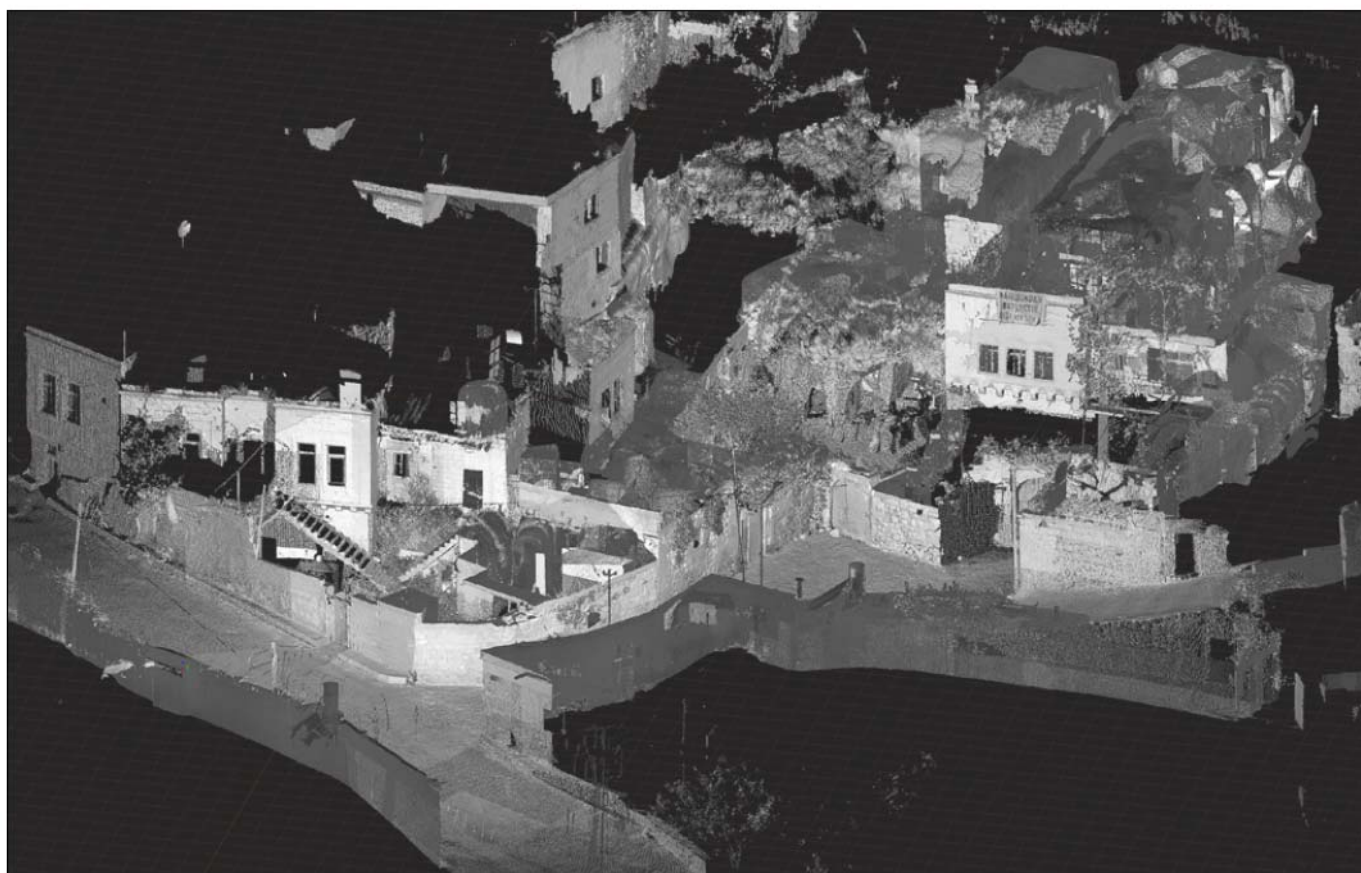
Fig. 3: Saklı and Ali Torun Kilise. Axonometric view of the complex. Point clouds.

2013 the complex passed on to the three heirs of the original owner (Fig. 3-4).

*Ali Torun Kilise* (coord. 38.61953; 34.86604 WGS4) Outside the Saklı Kilise, in the area closing the path to the NW, an high wall with a particular entrance arch surrounds the courtyard, leading to the Ali Torun Kilise (Fig. 3) (CRESCENZI C., 2012).

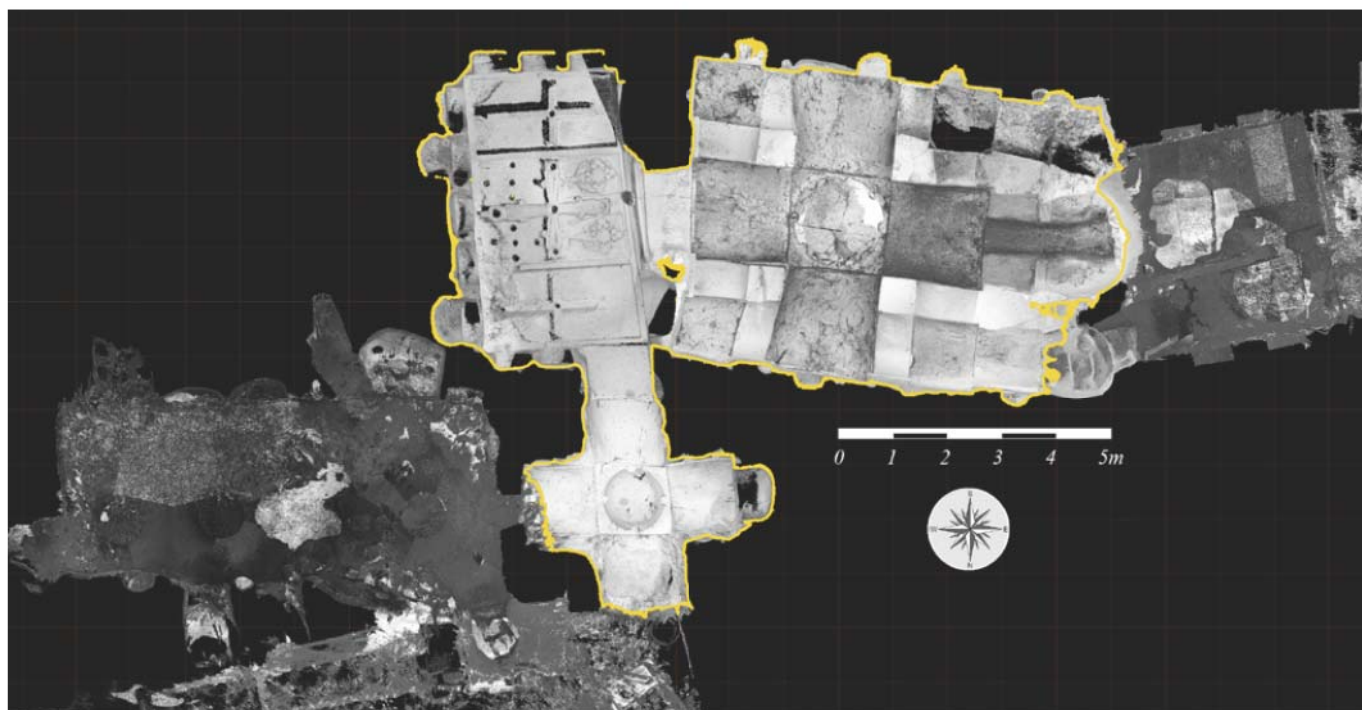
Fig. 5: Saklı Kilise. Bottom view of the vaults.

A wide door (1.57 m) communicates with the narthex (5.07 m x 2.86 height 2.41 m) (Figs. 5-6).

The E wall of the narthex is articulated in three parts: the entrance is framed with geometric frames and is flanked by two blind niches, that partly destroyed the bottom. The W wall has five blind niches, while E only three are at the N and S walls; specifically, the N has two blind ones, and in the third there is the passage for the small building of a Greek cross (Figs. 5-6-7).

In each of the upper panels of this cross, at a lower level, is sculpted a cup that still contains a cross with arms polylobate; in the panels below, there is still a cross figured five *cuppelle* (Fig. 5) (BIXIO R., DE PASCALE A., 2012).

The passage NE of the narthex leads into a small building with a Greek cross (3.9 x 3.9 m, height 2.51 m) (Figs. 5-7-8). A small apse (width 0.84 m, depth 0.81 m) is oriented to the E. Twinned niches were carved on the walls of the arms (0.31 x 0.63 m), some still visible. In the central span (1.076 x 1.07 m), on a small circular frame, the tambour (diameter 0.96 m, height 0.45 m) and the hemispherical dome (height 0.473 m) are set.

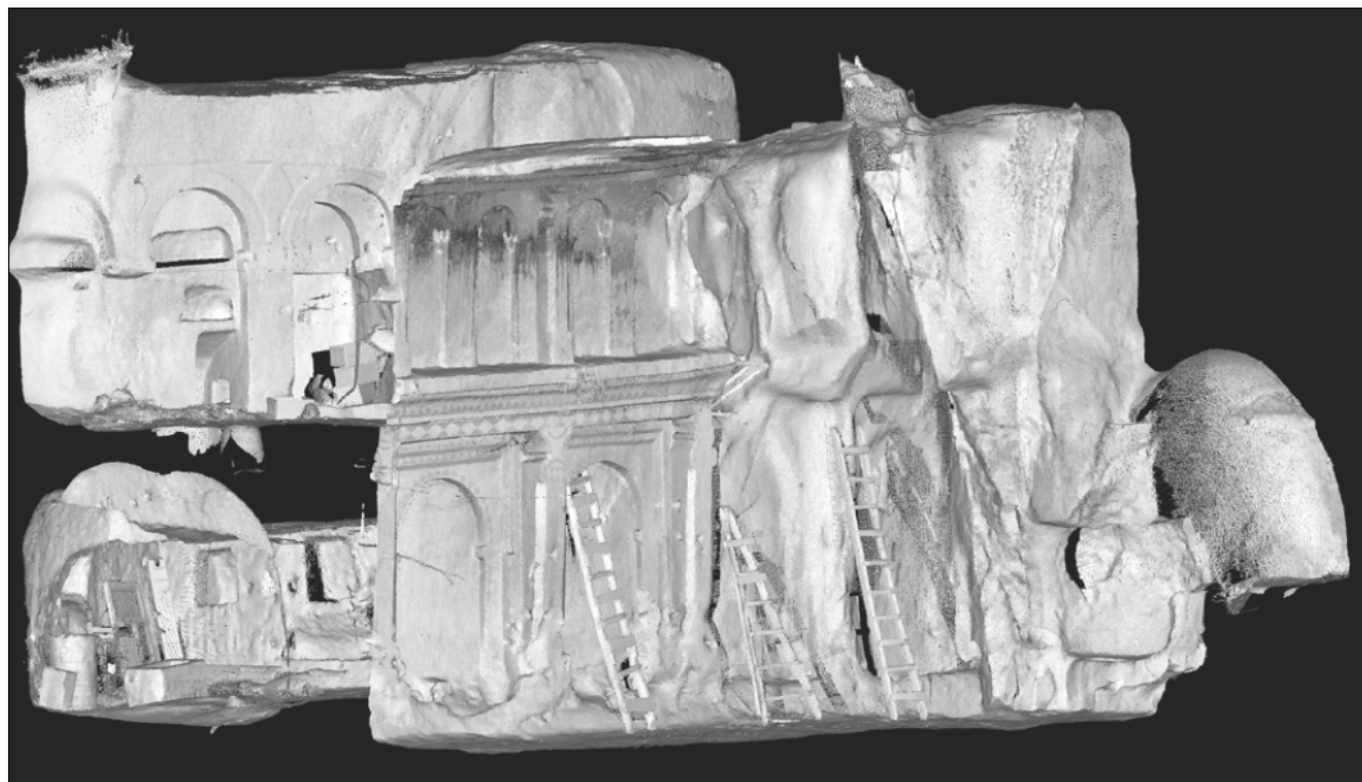
Fig. 10: axonometric section view of the hall church and the chapter house.

The roof of the nave is free from constructions that occlude the rocky facade, and the apse part is located under the street. The height is divided in two architectural orders; the lower, in turn, is divided by blind niches with double pitch compared to the superior one. On the basement there are residual traces of *subsellium* and a further raised element from which starts the pedestal of the pilaster (Fig. 10).

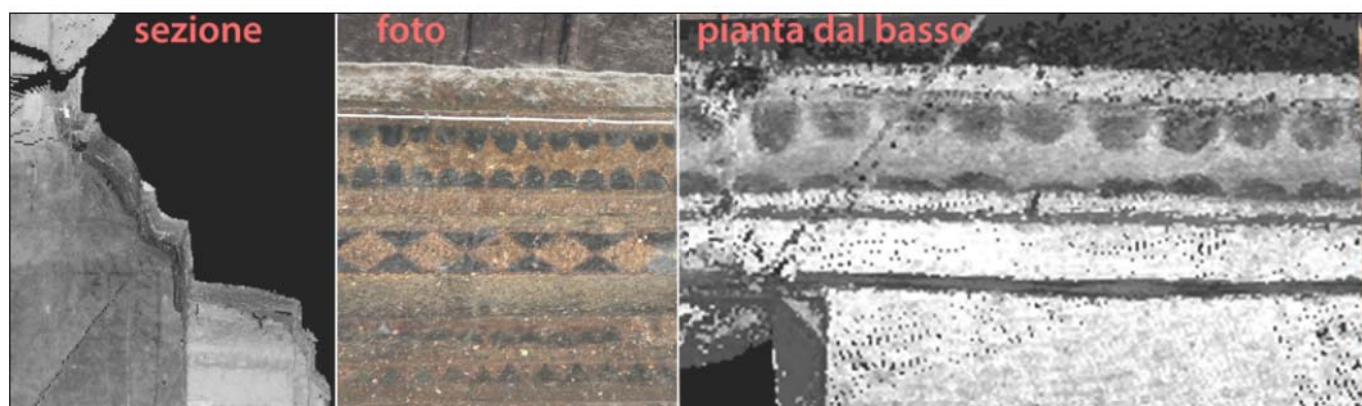
Fig. 11: trabeation: section of profile, photo of decoration and bottom view.  
 Fig. 11: trabeazione: sezione del profilo, foto della decorazione e prospetto.

The prominent trabeation (Fig. 11) (depth about 39 cm) divides the walls with a double architectural order. The elements are disintegrated. It is constituted, starting from the top to the bottom by: a band decorated by opposite black triangles highlighted by a double groove red line, which is set to the superior order; plain fillet; cyma recta decorated with a double black battlement; cyma recta (or convex surface) monochrome plain fillet; frieze decorated with diamonds. Each frame in the superior order includes twin blind niches; their arches are based on small capitals. The pilasters are surmounted by a simpler trabeation which decorates the plane roof.

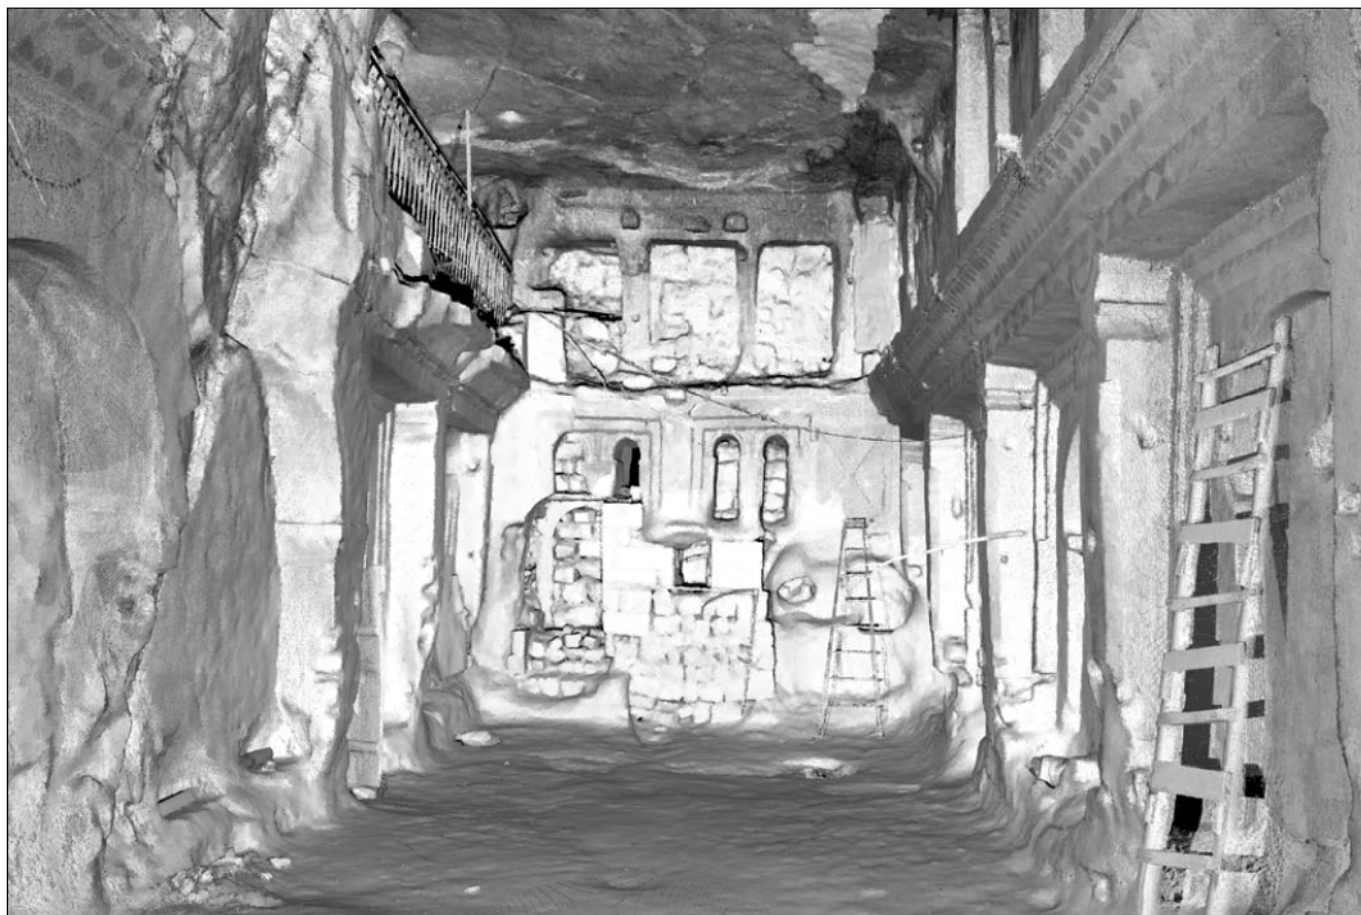
Fig. 13: perspective from the ESE.

The ESE wall, by the interior side, is architecturally relevant. On the superior order there are three wide opening, different in width, divided by pillars. On the right corner there is a walled opening; on the E the wall has been opened, and a small room with niche is visible. This level can be reached by the external stair, crossing built in masonry and rupestrian spaces. We can presume the presence of a *matroneum* (Fig. 13).

The surface under the described elements is seriously compromised. A masonry structure closes the original access, that was originally located at the centre of the wall. A NE of the wall there is a second walled opening with jamb and arch made of two pieces of cut stone. At the height threshold there is a step, probably part of the original subsellium (Fig. 13).
