Deciphering past and present atmospheric metal pollution of urban environments: the role of black crusts formed on historical constructions

Keywords: Black crusts, metal pollution, elemental imaging techniques, chemical equilibrium modelling, laurionite

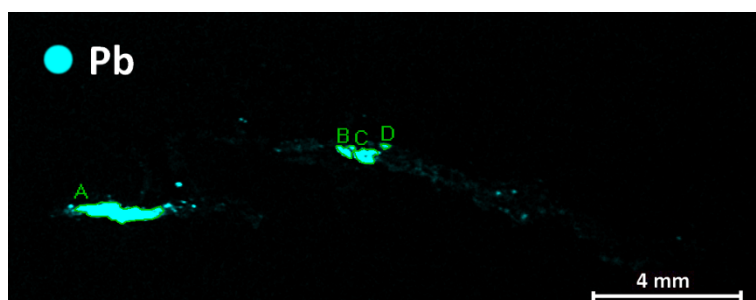
Figure S-3. Lead accumulation areas in the BCER thin section.
