Structural health monitoring (SHM) and Nondestructive testing (NDT) of slender masonry structures: A practical review

Francisco J. Pallarés ^{a,*}, Michele Betti ^b, Gianni Bartoli ^b, Luis Pallarés ^a

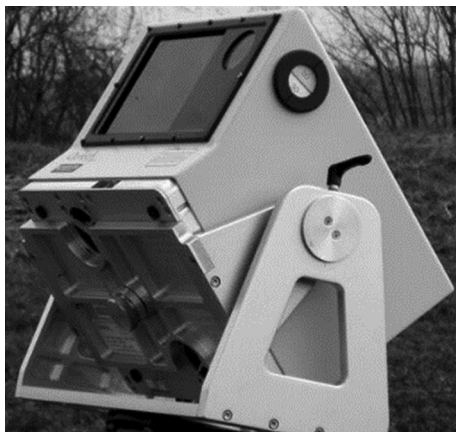
Fig. 3. Laser sensor [56].

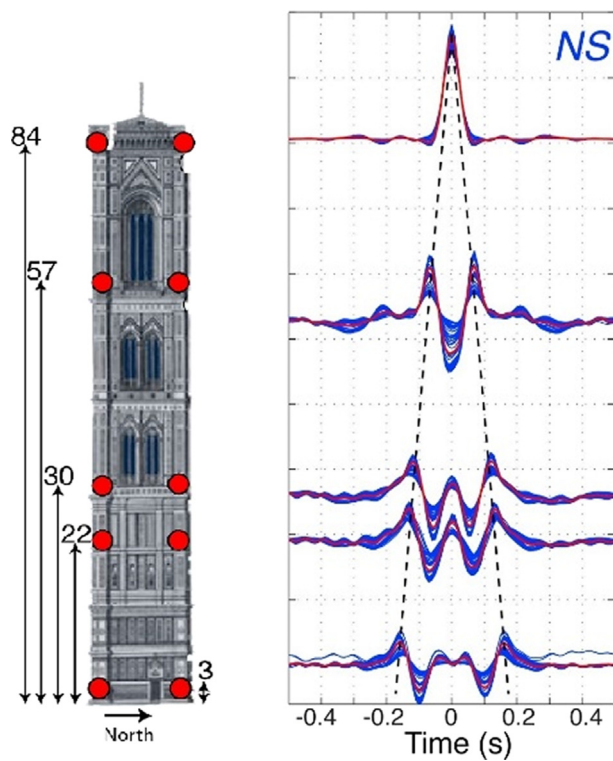
Fig. 7. Schematic deconvolution considering a virtual source at the top level and location of seismic stations [48].

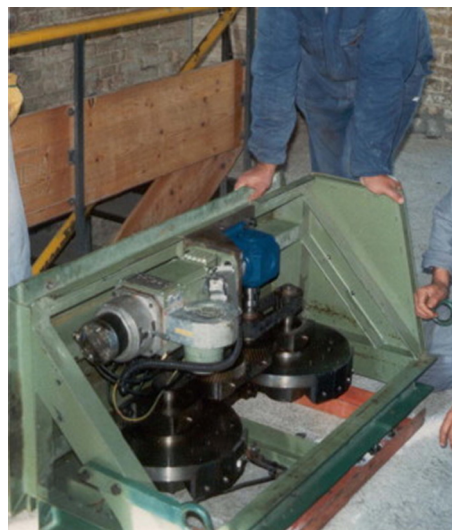
Fig. 9. Vibrodyne used in [84].

data. Only selected frequencies are excited and the level of the introduced forces must be carefully selected in order to protect the monument from any damage. Fig. 9 shows a vibrodyne used in dynamic test of a masonry tower [84], and Table 1 ('Dynamic excitation') shows the different type of generated dynamic excitation used in EMA: vibrodynes, swinging bells, impact hammer, explosions or rhythmic jumping.

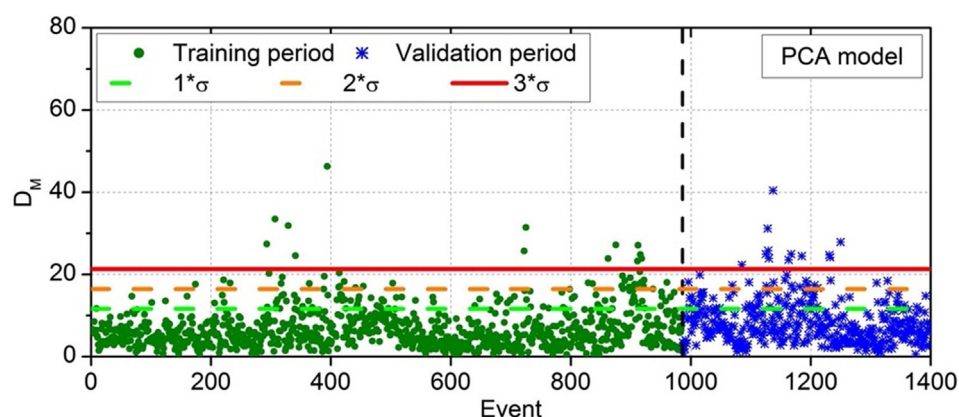
Fig. 13. Temperature effects and damage detection based on PCA [49].

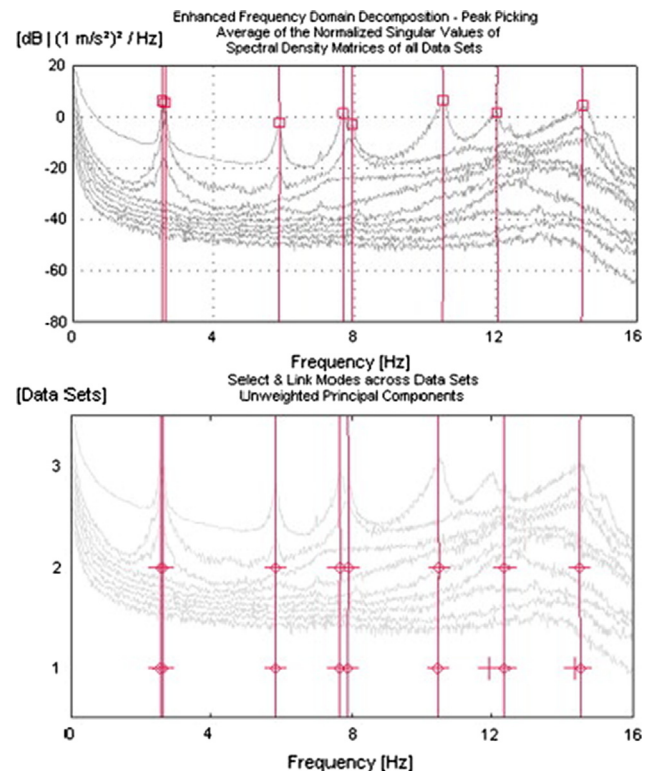
Fig. 14. Singular Values of the PSD function from EFDD technique (top), singular values from SSI-UPC technique (bottom) [111].
