Performance analysis of seismically excited statues in fixed-base and base-isolated conditions

Performance analysis of seismically excited statues in fixed-base and base-isolated conditions / Sorace, S; Terenzi, G. - STAMPA. - 8:(2015), pp. 6860-6871. (Intervento presentato al convegno Second European Conference on Earthquake Engineering and Seismology tenutosi a Istanbul nel 25-29 August 2014).

PERFORMANCE ANALYSIS OF SEISMICALLY EXCITED STATUES IN FIXED-BASE AND BASE-ISOLATED CONDITIONS

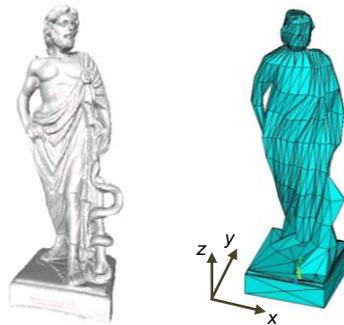
Figure 1. View of case study statue and relevant finite element model

The statue examined in this study, a view of which is shown in Figure 1, is a 17th century marble copy of a Hellenistic sculpture reproducing the Greek philosopher Socrates. The statue is constituted by a monolithic block including a thin parallelepiped pedestal, with square base section of 650 mm per side and height of 180 mm. The total height of the statue is about 1850 mm. Its aspect ratio is rather similar to the sculpture displayed on the left in Fig. 1, although with greater overall dimensions. On the other hand, due to the incorporation of the pedestal, global stability conditions are more favorable, and sensitivity to rocking is lower.

The finite element model of the statue was generated by the ANSYS calculus program (Swanson Analysis Systems 2012), widely used in research studies dedicated to structural systems made of small tensile strength materials. The model consists of a full mesh of about 15,800 solid octahedral isotropic elements, reproducing the real geometry with reasonable accuracy (image on the right in Figure 1, where the reference coordinate system of the model is displayed too). A smeared-crack “concrete”-type constitutive model was assigned to each isotropic element. In this model, the Willam-Warnke triaxial failure domain (Willam and Warnke 1974) is adopted to simulate the ultimate compressive, tensile and mixed compressive–tensile triaxial ultimate response of the material. The classical Drucker-Prager yield criterion (Drucker and Prager 1952) is assumed by the program to reproduce plastic deformations. The main mechanical parameters of the “concrete”-type model are as follows: st_o =shear transfer coefficient for open crack; st_c =shear transfer coefficient for closed crack; f_{crus} =uniaxial crushing design stress, coinciding with compressive strength f_c ; $f_{crus,b}$ =biaxial crushing stress; f_{crak} =uniaxial cracking stress, coinciding with tensile strength f_t ; E =Young modulus; and ν =Poisson ratio. The parameters defining the surface of Drucker-Prager domain are: c =cohesion; ϕ =friction angle; and ψ =dilatancy angle. The following basic values were adopted in the analysis: $st_o=0.15$, and $st_c=0.8$, which are typical choices for fine-grained materials, like the greyish Carrara marble constituting the case study sculpture; $f_{crus}=40$ MPa, $f_{crus,b}=1.2 \cdot f_{crus}=48$ MPa, $f_t=1.5$ MPa, $E=55,000$ MPa and $\nu=0.2$, according to the characteristics of the material illustrated above; and $c=2.12$ MPa, $\phi=30^\circ$ and $\psi=0^\circ$ (associated flow rule), from literature suggestions concerning the plasticity domain for concrete and stone-type elements (Chen 1982).

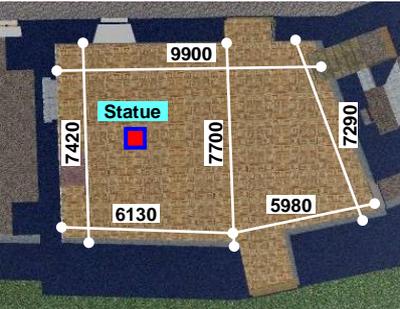
The ground floor design plan is illustrated by the drawing in Figure 3, where the position of the case study statue in the exhibition set is highlighted with a square.

Figure 3. Architectural plan of the ground floor (dimensions in millimeters) and position of the case study statue

The plan is shaped as an irregular pentagon, with a surface area of about 85 m². The floor is made of 55 mm-high HI-bond corrugated steel sheets, with a 55 mm-thick on-site cast reinforced concrete (R/C) slab on top. The main structure consists of primary and secondary beams in HEB 180 and HEB 100 Italian profiles, respectively, made of S235JR grade steel. Each primary beam spans over the shorter (transversal) dimension in plan, ranging from about 7.3 m to about 7.7 m, as shown in Figure 3, and is supported approximately at its midspan by a R/C column built on the basement level. This allows strongly reducing the bending moment, shear and vertical displacements induced by gravitational loads, and thus the cross section of the beams. This solution is mutually adopted for the fixed-base and base-isolated layouts of the floor. In the former case, each beam is joined to the

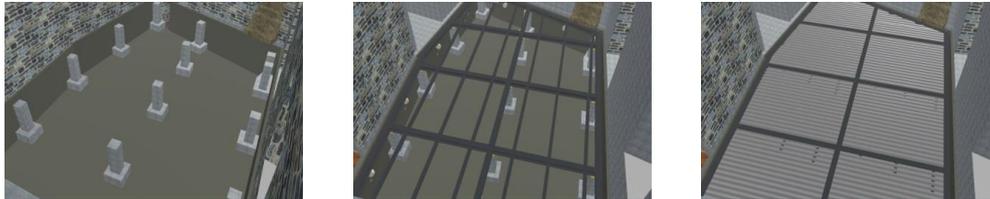
Figure 4 Construction steps of the ground floor steel structure in base-isolated configuration, before the casting of the R/C slab

relevant midspan column by a horizontal steel plate bolted to the column top section, and is borne at both ends by the perimeter masonry walls of the hall. In base-isolated configuration, two other rows of R/C columns are built, for a total of 15 columns, to support 15 DFP sliders to be placed below the five main beams. These additional ten columns represent the only difference between the two design hypotheses for the floor. Renderings of the construction steps of the floor steel structure for the base-isolated solution, before casting the R/C slab, are illustrated in Figure 4.

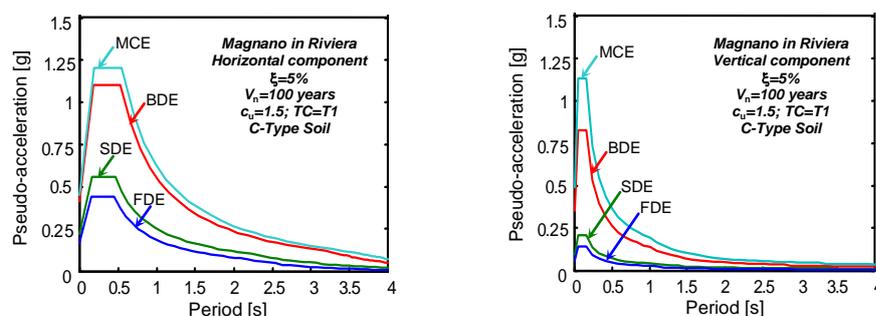
Figure 5. Normative pseudo-acceleration elastic response spectra for the horizontal and vertical components – Magnano in Riviera – FDE, SDE, BDE and MCE levels, $\xi=5\%$, $V_n=100$ years, $c_u=1.5$, TC=T1, and C-type soil

A visual representation of the normative response spectra at 5% linear viscous damping ratio ξ for Magnano in Riviera is offered in Figure 5, showing the graphs relevant to the horizontal and vertical components for the four seismic hazard design levels established by the Italian Standards, i.e. Frequent Design Earthquake (FDE, with $P_{VR}=81\%$); Serviceability Design Earthquake (SDE, with $P_{VR}=63\%$); Basic Design Earthquake (BDE, with $P_{VR}=10\%$); and Maximum Considered Earthquake (MCE, with $P_{VR}=5\%$). By referring to topographic category (TC) equal to T1 — flat surface — and C-type soil — deep deposits of dense or medium-dense sand, gravel or stiff clay from several ten to several hundred meters thick — for the site of the castle, the peak ground acceleration (PGA) values for the four seismic levels are as follows: 0.183 g (FDE), 0.229 g (SDE), 0.448 g (BDE), and 0.491 g (MCE), for the horizontal component; and 0.058 g (FDE), 0.083 g (SDE), 0.339 g (BDE), and 0.465 g (MCE), for the vertical component, with g =acceleration of gravity.

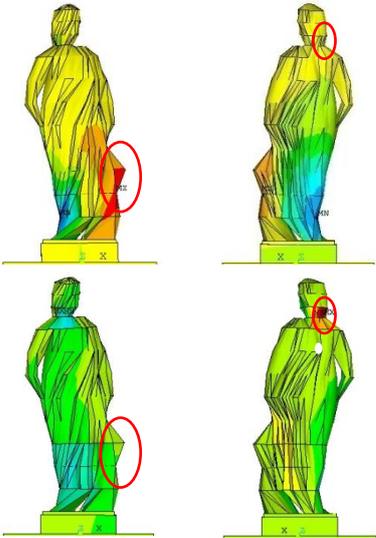
Figure 6. Normal stress distributions for the limit conditions of Rest (upper two images) and No rocking obtained from the most demanding among the seven groups of accelerograms

The peak tensile stress values in the plots of Figure 6 are equal to about 0.8 MPa (Rest) and 1.2 MPa (No rocking), both lower than f_t . These values quantitatively confirm the uncracked response for these two PLs. The mean values obtained from the response to the seven groups of accelerograms are only slightly lower (about 0.76 MPa and 1.14 MPa, respectively), highlighting the limited scattering of response for the suites of artificial ground motions used as input in the analysis. The plots in Figure 7 outline a noticeable set of cracks that would be clearly visible in the real statue, both in the leg and the neck, also figuratively showing the attainment of Damage control/Artistic value safety PL. The activation of cracks is recorded in 5.6% of Gauss points of the model, for the most demanding group

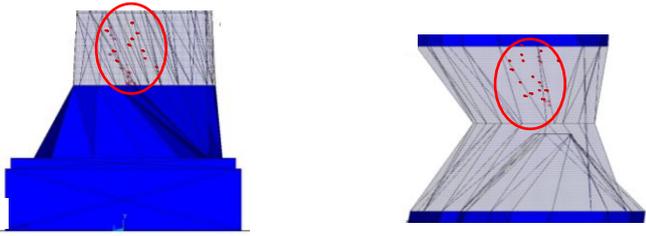
Figure 7. Cracked configurations of the left leg knee (left image) and the rear portion of the neck for the limit conditions of Damage control/Artistic value safety obtained from the most demanding among the seven groups of accelerograms

As way of example of the responses obtained at the limit conditions of the four PLs, the following drawings and graphs are reproduced in Figures 6 through 9, for the most demanding among the seven groups of accelerograms used in the analysis: for Rest and No rocking, the normal stress distribution in the model, with the two areas subjected to the highest tensile stresses, that is, the left leg knee and the rear portion of the neck, highlighted by red ellipses (Figure 6); the cracked configuration of the same two critical zones, plotted in zoomed view and coloured in light grey, for Damage control/Artistic value safety (Figure 7); the ultimate cracked configuration of the front and rear portions of the neck, again in zoomed view, for Collapse prevention (Figure 8); and the vertical displacement time-histories of the joint situated on the rear left corner of the pedestal, for No rocking and Collapse prevention (Figure 9).

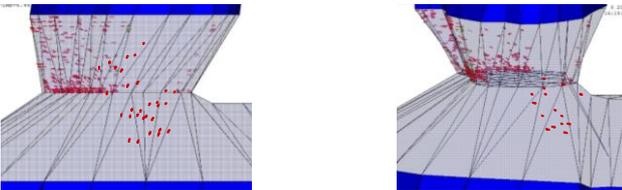
Figure 8. Cracked configurations of the front (left image) and rear portion of the neck for the limit conditions of Collapse prevention obtained from the most demanding among the seven groups of accelerograms

The cracked configuration depicted in Figure 8 clearly illustrates that numerical collapse, and thus the achievement of the limit condition for Collapse prevention PL, is caused by the local failure of the base section of the neck, which is the most vulnerable area of the model.

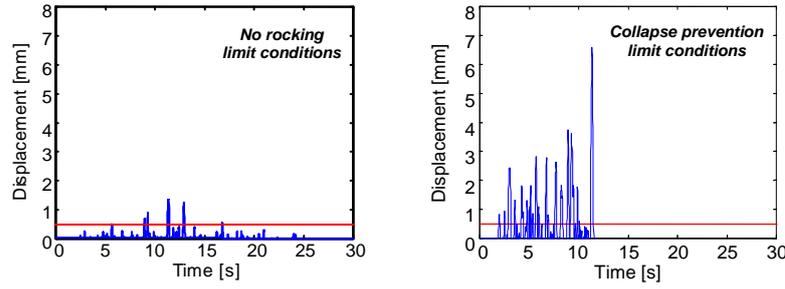
Figure 9. Vertical displacement time-histories of the joint situated on the rear left corner of the pedestal for the limit conditions of No rocking and Collapse prevention obtained from the most demanding among the seven groups of accelerograms

The vertical displacement time-history corresponding to the achievement of the limit conditions for No rocking, plotted in the left graph of Figure 9, shows six peaks greater than the assumed threshold of 0.5 mm (highlighted by a red horizontal segment in the graph), with a maximum of 1.3 mm. Each of the remaining six groups of input motions produced five peaks greater than 0.5 mm, giving rise to a mean maximum peak of 1.1 mm over the seven groups. As illustrated in the right graph of Figure 9, the time-history relevant to the limit conditions of Collapse prevention stopped immediately after the attainment of the maximum uplift, equal to 6.6 mm, as a consequence of the

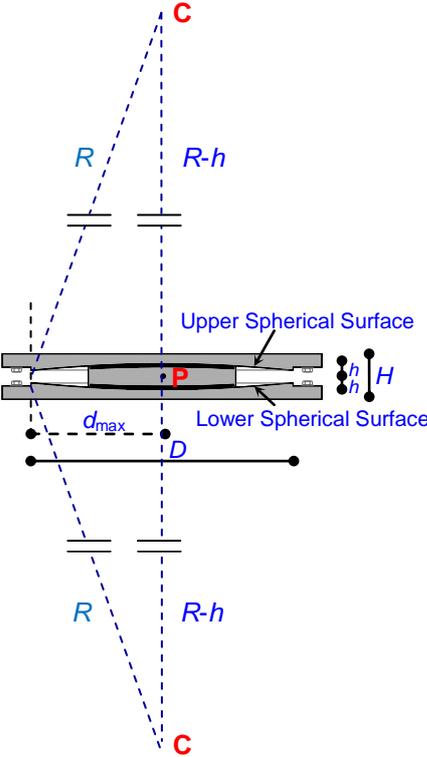
Figure 10. Cross section of a DFP isolator with equal sliding surfaces

As shown in the drawing in Figure 10, the double-friction pendulum sliders (Fenz and Constantinou 2006, Christopoulos and Filiatrault 2006) selected as isolating devices for this design hypothesis consist of two facing spherical concave surfaces, separated by an articulated double friction slider, which produce two independent pendulum response mechanisms. The DFP devices in standard production are characterized by identical properties of the two surfaces, and namely, by referring to the nomenclature in Figure 10: radius R ; slider center-to-surface distance h (i.e. the distance between the “pivot point” P of the articulated slider and the face of each spherical surface); effective pendulum length $R-h$ (i.e. the distance between P and the center C of each surface); diameter of the horizontal projection of the spherical surface D ; and friction coefficient μ . The resulting effective pendulum length L_{DFP} of the isolator is equal to twice the effective pendulum length of each surface, i.e. $L_{DFP} = 2 \cdot (R-h) = 2R-2h$.

isolators, as derived from the reference manufacturer’s catalogue (FIP 2013): $L_{DFP}=3125$ mm; $d_{max}=250$ mm; $\mu=0.025$; $D=490$ mm; $T_e=3.1$ s; and $\xi_e=15.2\%$. The height H (Figure 10) is equal to 94 mm.

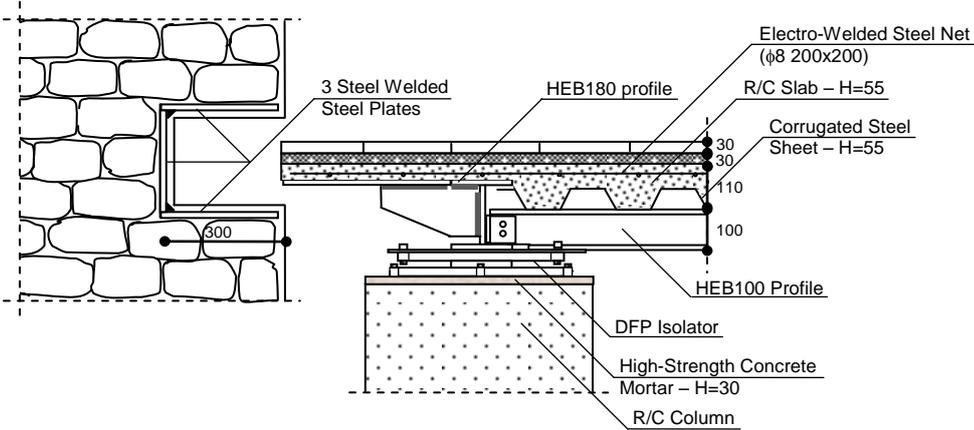
Figure 11. Installation details of a DFP isolator situated on top of a lateral column (dimensions in mm)

A drawing illustrating the details of installation of an isolator placed on top of a lateral column is presented in Figure 11. The depth of the continuous carving of the perimeter walls of the hall, reinforced by a C-shaped steel beam composed of three welded plates, was dimensioned in order to accommodate d_{max} . The only equipment situated on the floor is the power installation. To safely accommodate d_{max} too, power cables are arranged in a circular winding prior to connecting them to the floor structure, according to a classical and inexpensive installation layout adopted for base-isolated buildings (Sorace and Terenzi 2001, 2008).

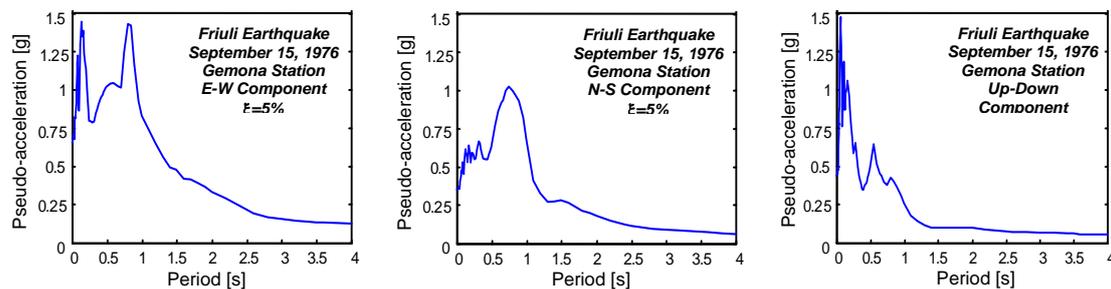
Figure 12. Pseudo-acceleration elastic response spectra at $\xi=5\%$ of the E-W and N-S horizontal components, and the vertical component recorded in Gemona station on September 15, 1976

A supplementary control was carried out by developing a further set of time-history analyses with the most demanding real ground motions recorded in Gemona, a neighbor town to Magnano in Riviera, during the Friuli earthquake in 1976. These ground motions, characterized by a distance of 6.2 km from the surface projection of the causative fault, a fault-thrust mechanism, and moment magnitude $M_w=5.9$, are the E-W, N-S and up-down (vertical) components of the main shock recorded on September 15, with PGAs of 0.642 g, 0.329 g and 0.485 g, respectively, and the pseudo-acceleration elastic response spectra at 5% linear viscous damping ratio plotted in Figure 12. As observed in the Introduction, these ground motions caused very severe damage and partial disruption to the castle of Prampero, situated at about 1.5 km from Gemona recording station, which had been already partly damaged by a comparably demanding ground motion sequence occurred on May 6.

The application of the real motions produced a slightly lower response of the redesigned structure of the castle as compared to the normative MCE-scaled groups of artificial accelerograms. Indeed, the two spectral peaks of the E-W component, situated at about 0.8 s and 0.1 s, and the peaks of the N-S and up-down components, nearing 0.75 s and 0.1 s, respectively, are outside the range [0.3 s – 0.6 s] of the main vibration periods of the masonry structure of the castle. All remaining ordinates, up to about 2 s, are lower for the real motions.

On the other hand, the spectral ordinates of the latter are higher than the MCE ones in the period range [3 s–3.5 s], which includes the fundamental vibration period of the base-isolated floor. The results of the analysis in this configuration highlight peak displacements of 241 and 226 mm along the longitudinal and transversal directions in plan, that is, 8% and 7% greater than the values found for the most demanding MCE-scaled accelerograms, respectively, but still lower than the maximum available displacement d_{\max} of the isolators.
